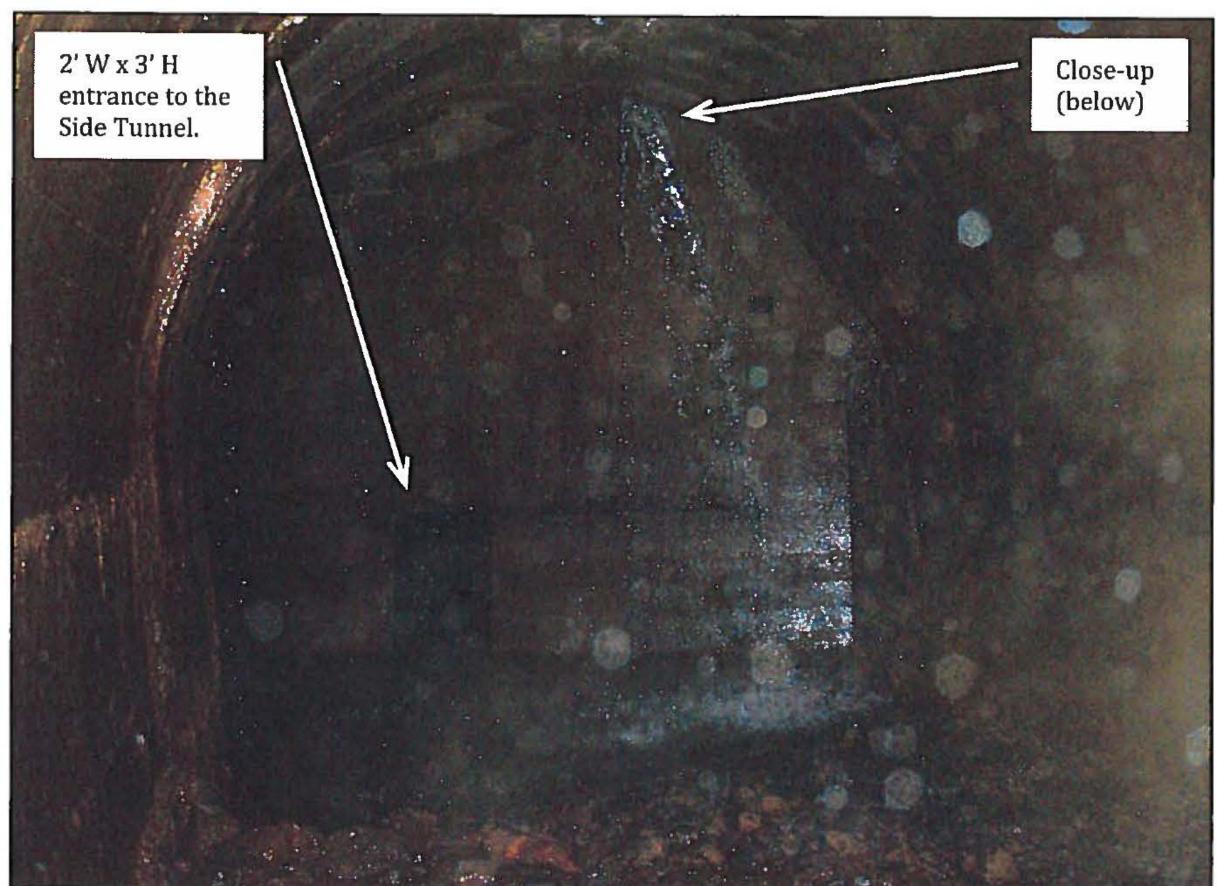
Photo 5 - View from inside the Side Tunnel looking west toward the Main Tunnel's formed concrete outside wall. The Main Tunnel extends upstream (photo right) another ± 30 feet before bending eastward to approach the gate tower (See Figure 1).

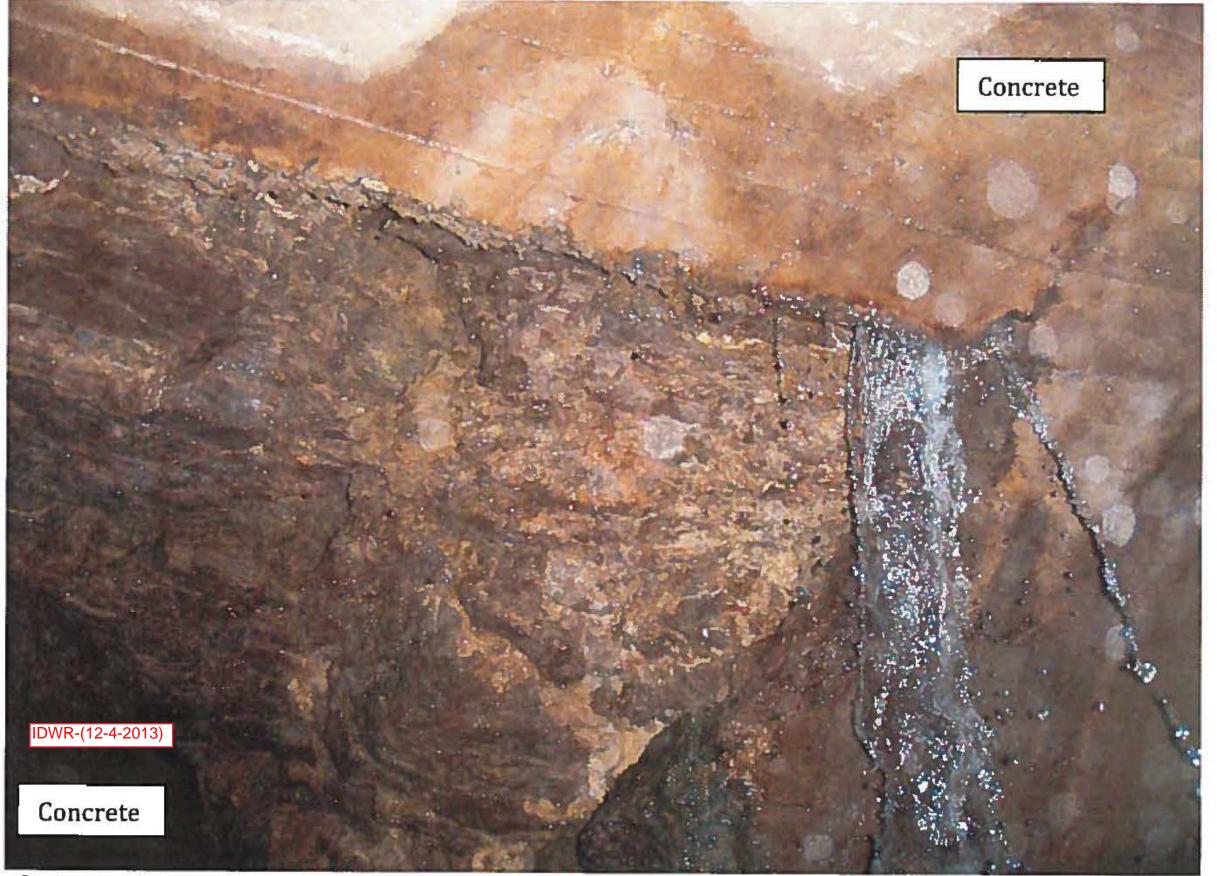
Photo 6 - Substantial leakage occurs at the Side Tunnel connection with the Main Tunnel.
