**Environmental Defense Institute**  
**Troy, Idaho 83871-0220**  
<https://environmental-defense-institute.org>

**Mackay Dam: A Preventable Disaster**

**We are requesting that your offices take preventative action to protect the town of Mackay, Idaho from the collapse of Mackay Dam. Pursuant to Idaho Code Title 42 Chapters 1701-1721, we are requesting that an inspection and administrative enforcement action be commenced for Mackay Dam along with development of an emergency evacuation plan and publication to all residents that lie within the area of inundation.**

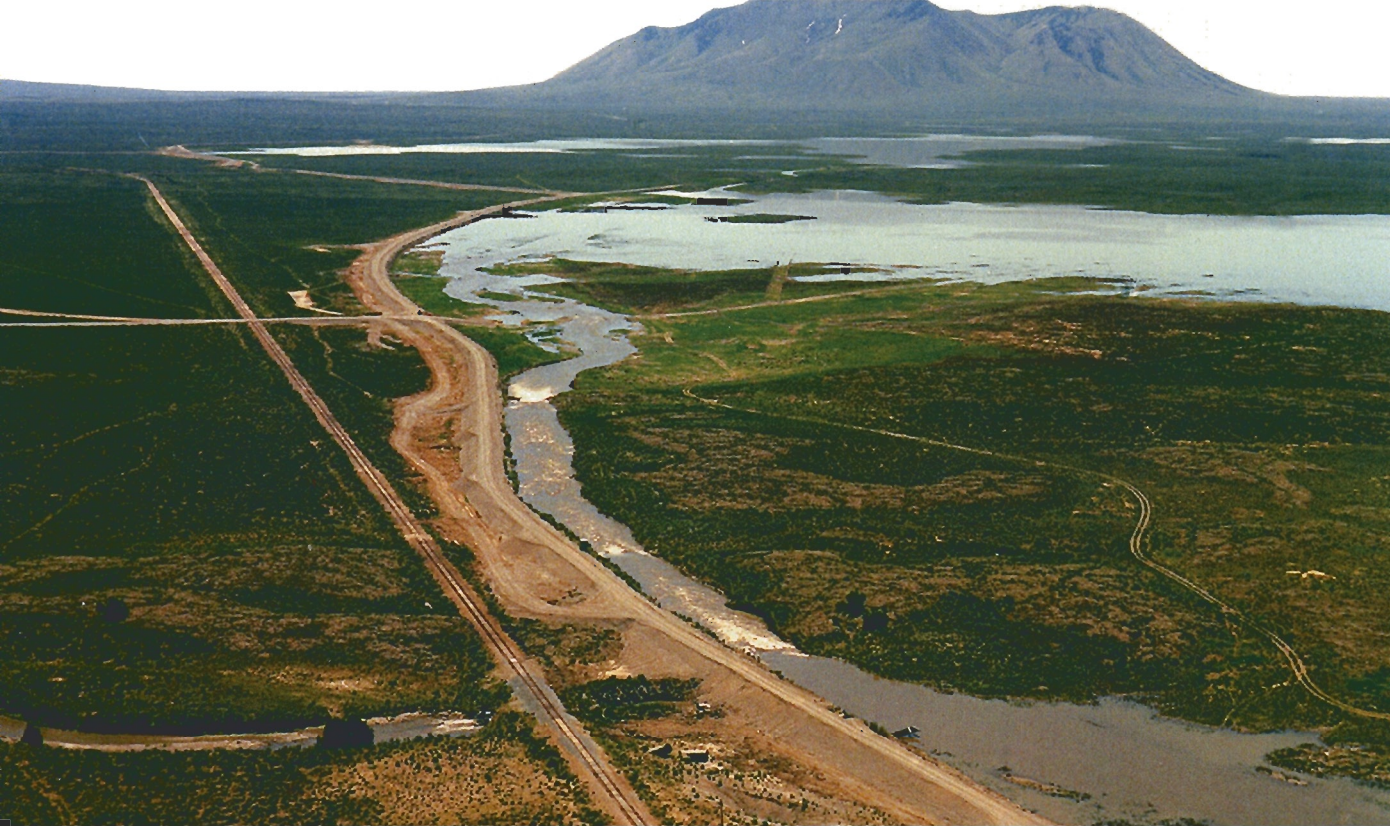
TABLE 7. RESULTS OF PMF-INDUCED OVERTOPPING FAILURE

<u>Location (Approximate Elevation, ft msl)</u>	<u>Streambed Elevation (ft msl)</u>	<u>Peak Water Surface Elevation (ft msl)</u>	<u>Peak Flood Flow (cfs)</u>	<u>Peak Water Velocity (ft/sec)</u>	<u>Time of Wave Arrival (hr)</u>
Mackay Dam (6076)	5997	6078	306,700	8.5	0.0
Arco (5310-5410)	5309	5319	147,720	5.6	6.7
INEL Diversion (5065)	5043	5073	71,850	1.0	10.0
CFA (4928-4940)	4935	4942	67,830	3.4	12.8
TRA (4920-4925)	4919	4924	67,170	2.8	13.2
CPP (4914-4930)	4911	4917	66,830	2.7	13.5
NRF (4845-4850)	4846	4851	61,620	1.9	16.4
TAN/LOFT (4780-4795)	4778	4786	34,810	1.1	34.5

Total Reservoir Release: 142,330 ac-ft

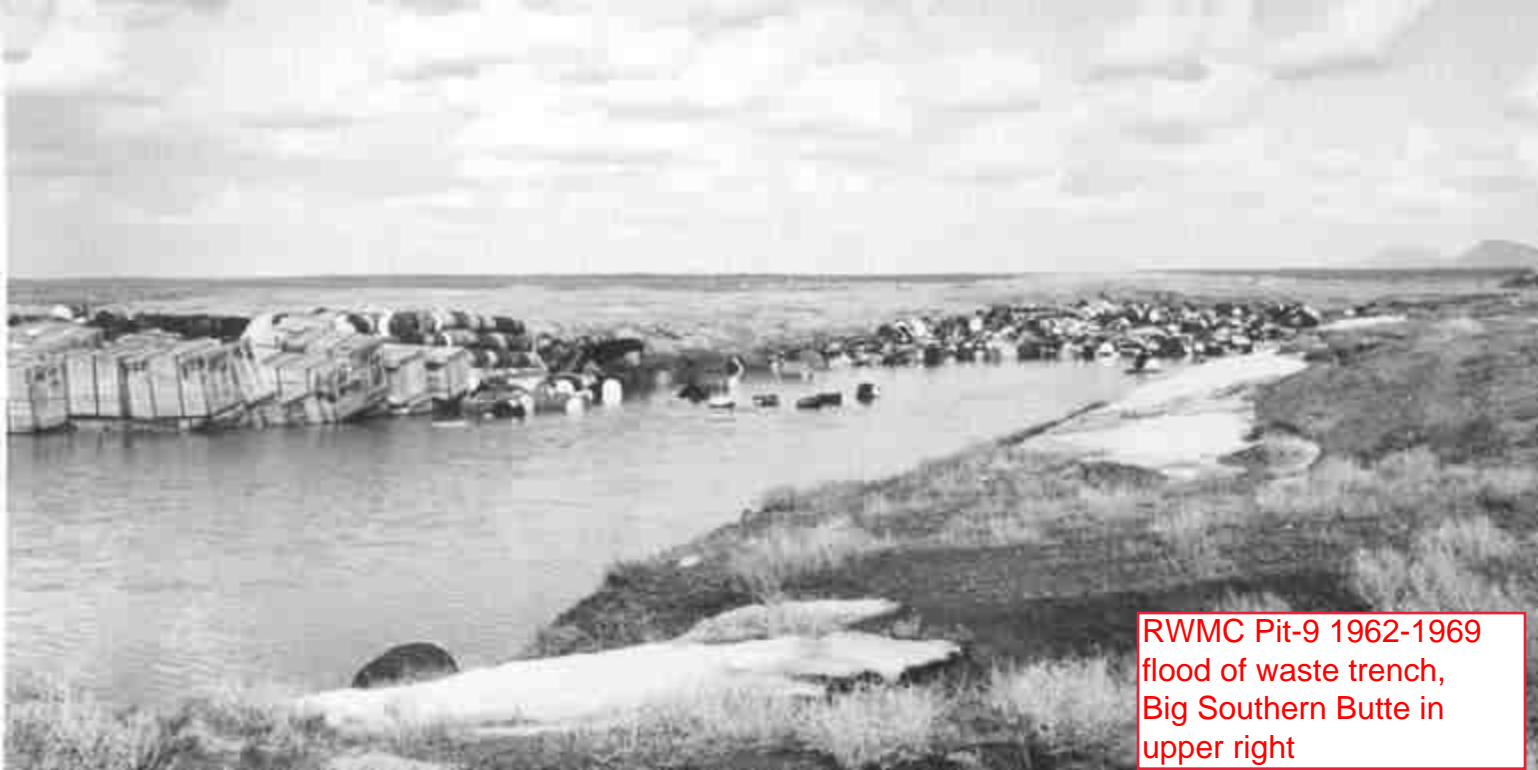
RWMC Pit-9 1962-1969  
flood of waste trench,  
Big Southern Butte in  
upper right

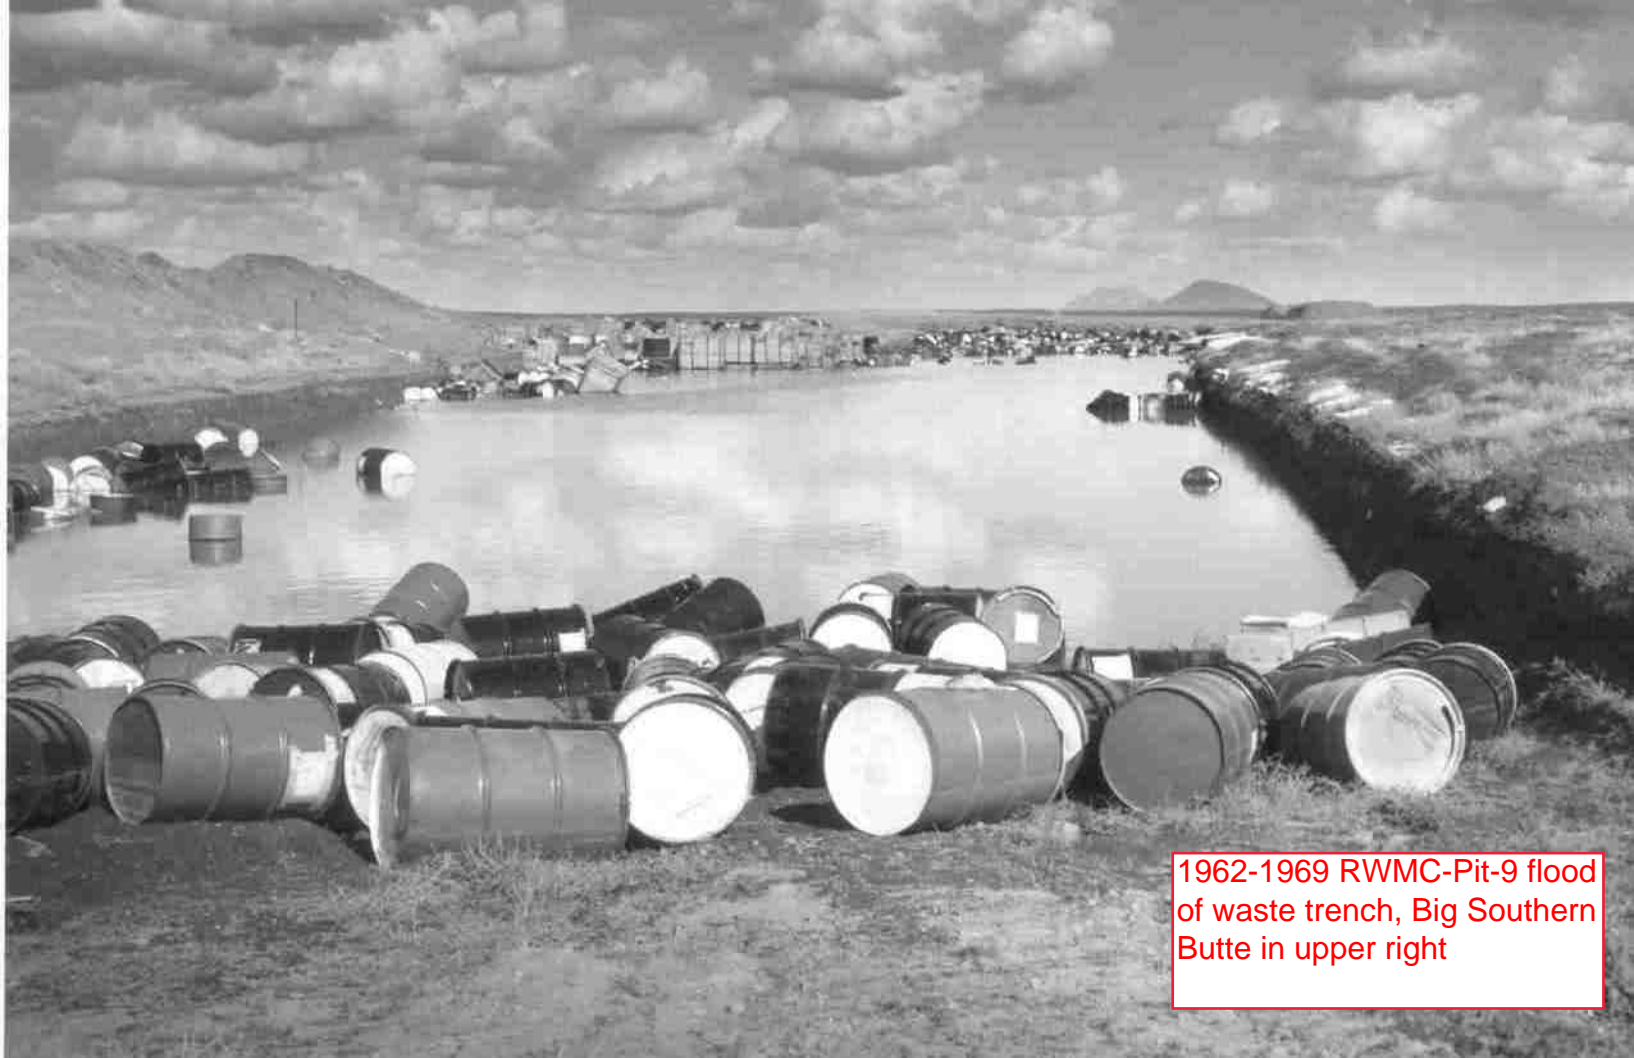
1962-1969 RWMC-Pit-9 flood  
of waste trench, Big Southern  
Butte in upper right
